# CASE STUDY

## Redcliffe Water Mains Burst

## Unauthorised Use in Sports Field

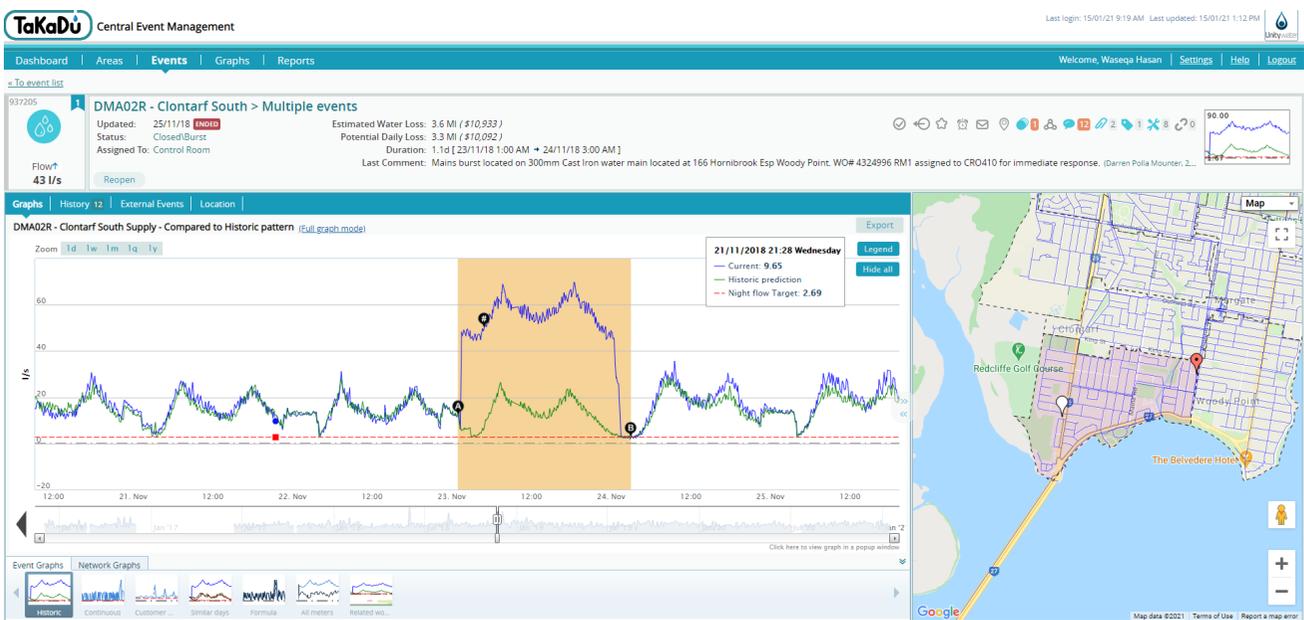
**Figure 1: Takadu data shows an abnormally high flow (blue) instead of predicted flow (green) indicating a leak or burst in the network**

After receiving the alerts, Unitywater’s 24/7 Control Room operators checked the sensor patterns and analysed data from the Takadu CEM. By analysing the data, Unitywater’s System Loss engineers concluded this significant event was a water mains break. The team located the leak down to a specific DMA area within Unitywater’s Smart Water Network by analysing signals from sensors and meters at the critical pressure points. An immediate request was made to Detection Services to survey the identified DMA.

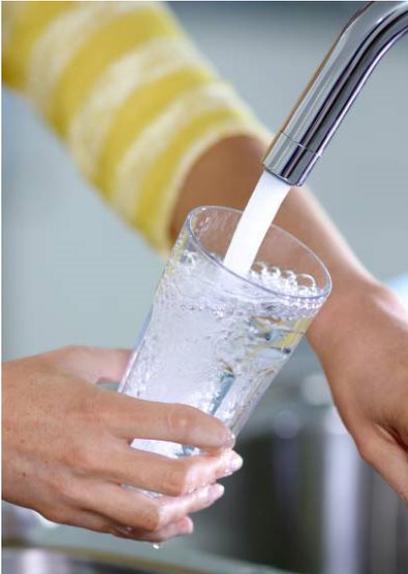
Initially the break was thought to have occurred in a stormwater culvert, which would be difficult to locate in the DMA. However, after thorough investigation of the DMA, a large mains burst was located under the footpath which was discharging directly into a stormwater drain and running directly into the bay. This type of burst would have been easily missed without the Smart Water Network and CEM system.

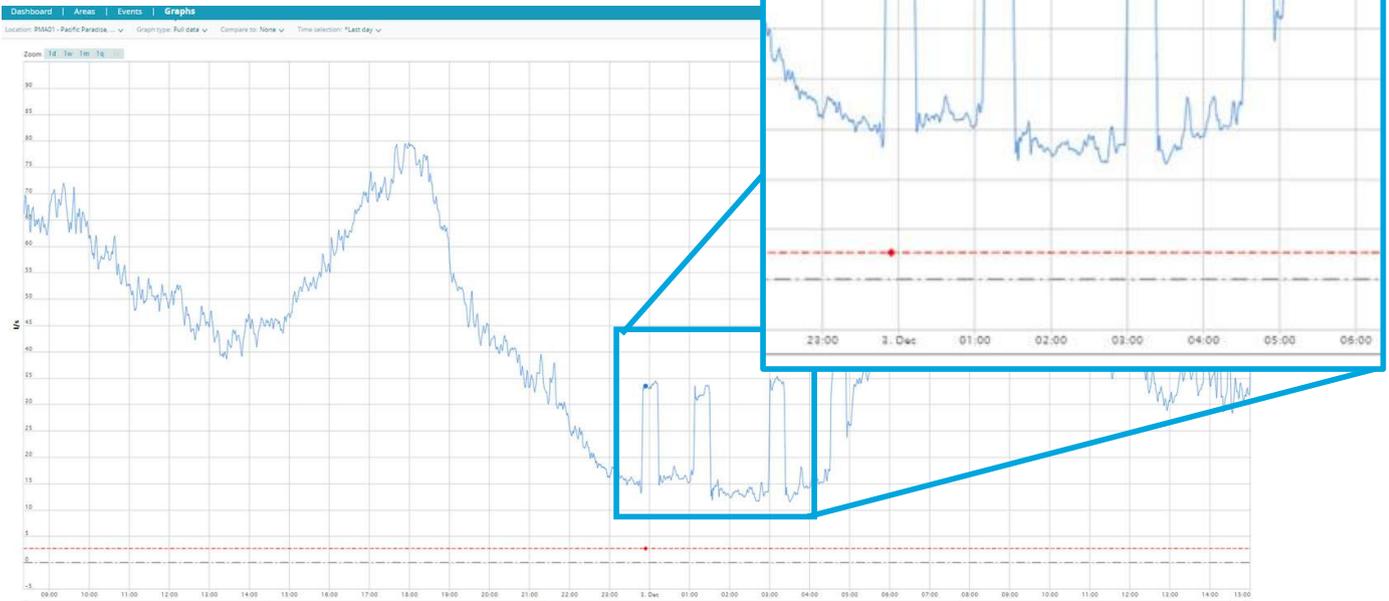
Figure 1: Smart Water Network Trends from Takadu CEM indicating abnormal use during night-hours

Over a three-day period, system loss engineers observed frequent and consistent increases in water use of approximately 20 L/s (litres per seconds) for 15 minutes every hour, from midnight to 3am.

This flow was identified through one of Unitywater's flowmeters and was flagged as unexpected usage by the Takadu CEM system.

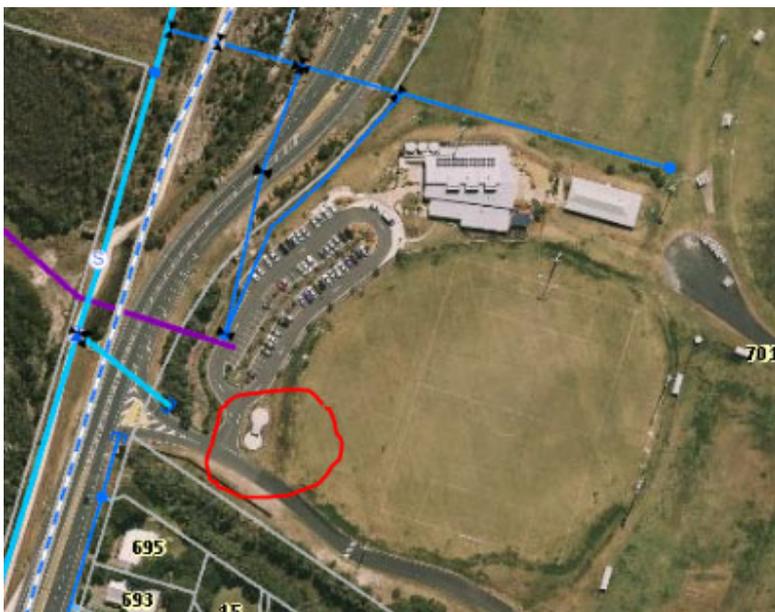
Figure 1: Area of unauthorised water use found via CEM data

Unitywater's 24/7 Control Room operators had identified usage spikes in flow as tanks (circled below in red) at the sports field started filling-up. A test was undertaken onsite to check the flows at the nearest Pressure Reduction Valve (PRV). This test concluded when the tanks started filling and stopping at the same time as the flows at the PRV. All onsite inspections indicated that the two storage tanks were filling up with drinkable water through the 100mm unmetered fire service.
